Plexco Service Tee Celcon® Polyacetal Caps

On September 6, 2007 the Department of Transportation Pipeline and Hazardous Materials Safety Administration (DOT PHMSA) issued an updated notification on the susceptibility to premature brittle-like cracking of older plastic pipe. Portions of this report regarding Plexco service tee Celcon® polyacetal may be misconstrued and as such we offer the following clarification.

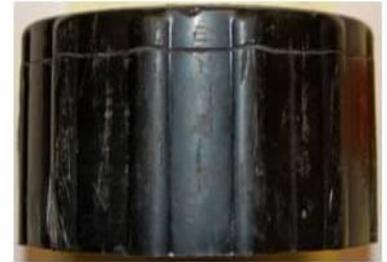
Photo #1

Plexco did use Celcon® polyacetal plastic material in tapping tee cap production. The material itself has not been found to be a problem. There have only been problems associated with caps that were not properly installed. Celcon® caps were designed to be hand tightened only, not tightened with a wrench. Celcon® polyacetal is a thermoset material and as such is less forgiving of overstress in applications than is polyethylene. Those caps that have been over tightened with a wrench could fail (notice wrench marks in photo #1). The over tightening of caps was identified as a problem in the 1995-96 time frame.

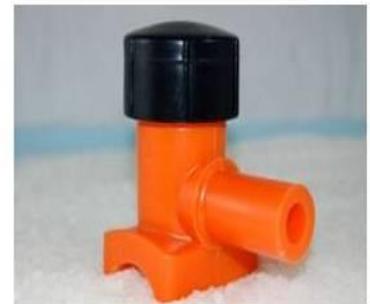
Photo #2

All Plexco tapping tees that are orange used Celcon® in producing caps (see photo #2). The original cap had an o-ring seal. Most of the time, the labels on the tapping tee were made of foil. Replacement caps made of polyethylene are available for purchase to replace original caps that may have been over tightened.

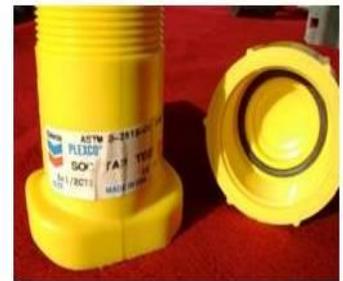
Photo #3

Plexco tapping tees produced in yellow before 1996 used Celcon® in producing caps (see photo #3). After 1996 Plexco started manufacturing polyethylene tapping tee caps. Plexco continued to manufacture some of the Celcon® polyacetal caps through March of 2000, because several customers specifically requested the Celcon® polyacetal caps over the polyethylene caps. No Celcon® polyacetal caps were produced after March 2000. Often the labels on these caps were made of paper. Replacement caps in polyethylene are available for purchase to replace original caps that may have been over tightened.

All Plexco labeled standard size tapping tee Celcon® caps used an o-ring seal inside the cap instead of a flat gasket (see photo # 3).
